LEVEL
RARITAN RIVER BASIN
RARITAN RIVER
SOMERSET COUNTY
NEW JERSEY

ROBERT STREET DAM

NJ 00371

PHASE 1 INSPECTION REPORT NATIONAL DAM SAFETY PROGRAM

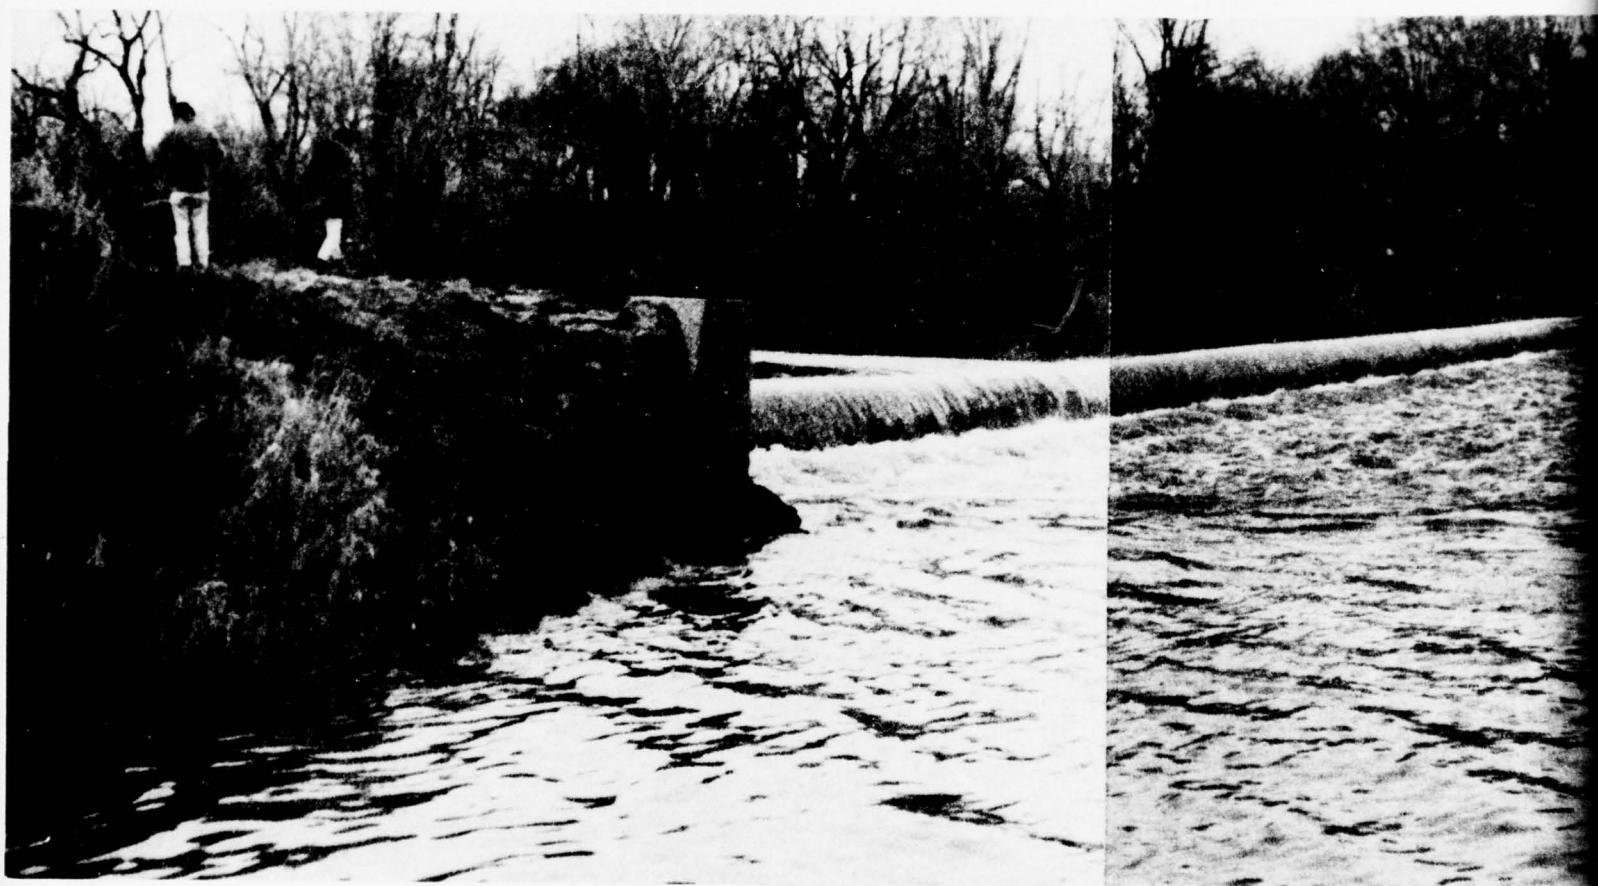
View of dam from right abutment looking upstream
(Dec. 5, 1978)

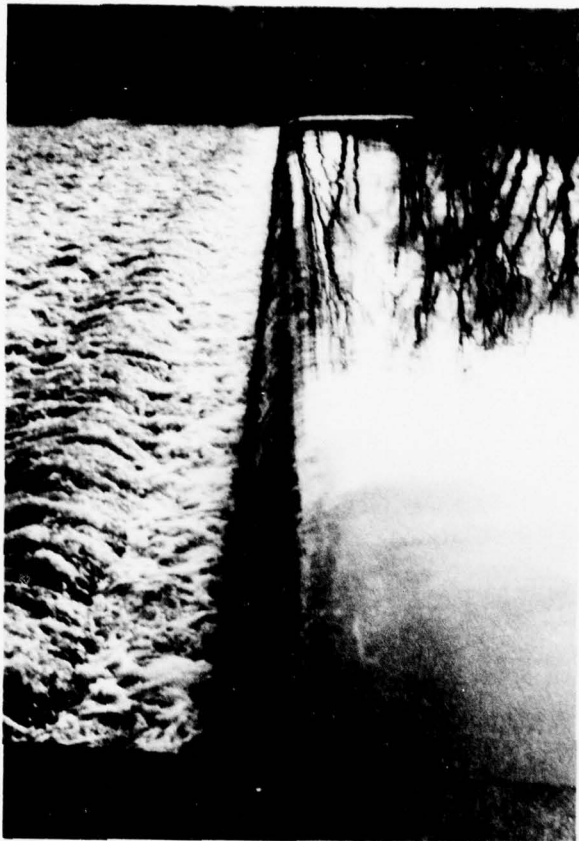
uniform flow of water over the spillway indicated that there are no major failures or distortions in the spillway (Photo 1).

The reservoir area immediately behind the dam is poorly defined because of the small impoundment relative to the large river flow (Photo 4). The water was brownish in color indicating a relatively high sediment load. Some brush was observed caught on the upstream edge of the dam near the south (right) abutment (Photo 1). There appears to be considerable debris potential.

VISUAL EXAMINATION OF	OBSERVATIONS	REMARKS OR RECOMMENDATIONS
SLOPES	Very gently sloping and moderate to heavily wooded. Trees along rim of reservoir are tilting towards reservoir and may fall into the reservoir should erosion of their foundation continue.	Trees leaning steeply towards the reservoir should be removed to prevent their falling into the reservoir and restricting flow over the spillway.
SEDIMENTATION	Sediments blocking the Dead River deflection boom and the brown colored reservoir water indicate that there is a high potential for sedimentation; however, no indication of excessive deposition behind the dam was observed. Some debris was observed on right (south) side of dam. (Photo 1)

Photo 1 - View of
dam from left (north)
abutment

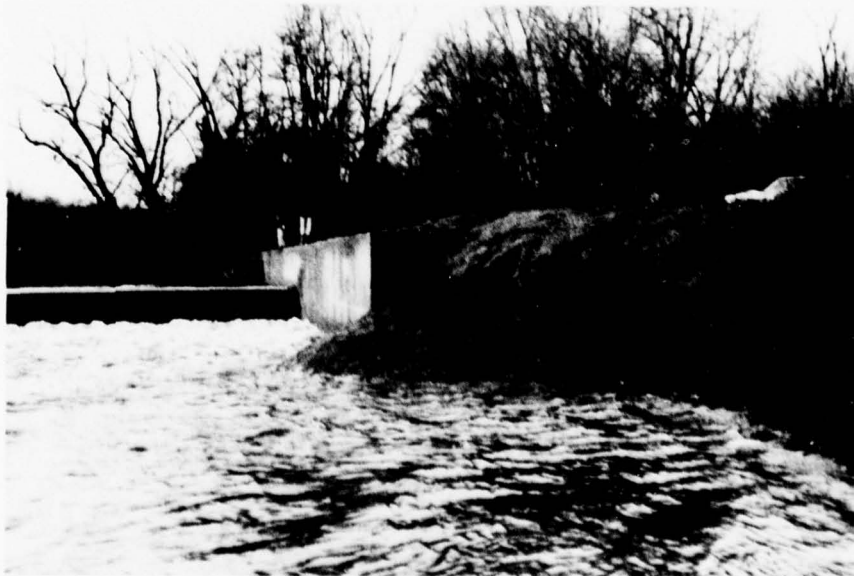
The embankments behind the wing walls have a rough concrete surface, as shown in Plate 6 and Photo 2. There was no noticeable erosion of the embankments behind the wing walls. The embankment surfacing just upstream of the left wing wall shows incipient failure cracks, also the present configuration of the extent of the river bank, upstream and downstream of the wing walls (Plate 6), indicates that the river bank and riprap, as shown in Plate 2, has been eroded downstream of the wing walls.

Photo 2 - View of left (north)
abutment looking upstream.

erosion of the embankment immediately downstream from the wing walls has occurred since reconstruction of the dam in 1964. If erosion of the embankment continues, the wing walls may be undermined and suffer structural damage due to lack of foundation support. Therefore, it is recommended that riprap or other slope protection should be placed on the embankment downstream from the wing walls as soon as possible. In addition, consideration may also be given to angling the upstream and downstream ends of the wing wall into the bank, similar in configuration to the south wing wall and riprap protection, in order to further reduce potential erosion of the abutment and the embankments.

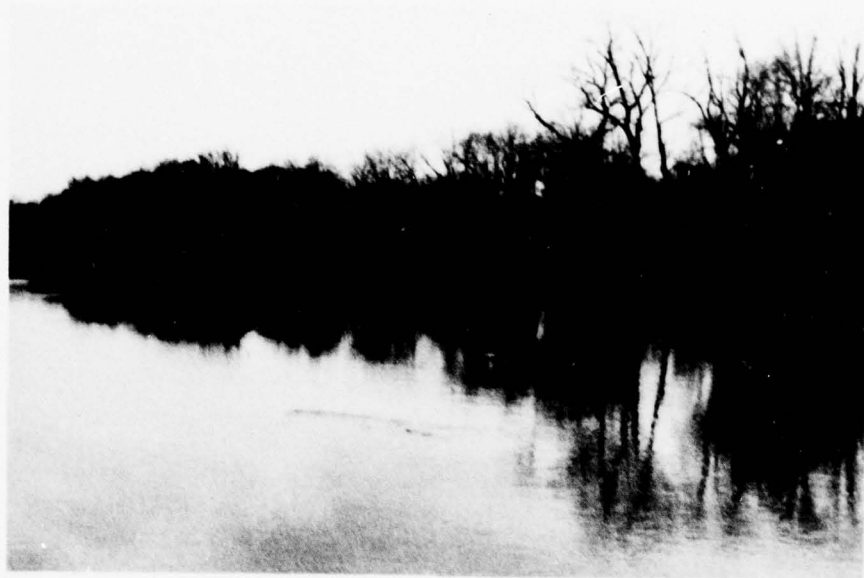
The slopes of the overbank channel are nearly flat and covered with a moderate to heavy growth of trees and brush. Several of the trees along the rim of the overbank channel are leaning towards the water, as shown in Photo 4, apparently due to erosion at the bank. One house and an automobile junk yard were observed on the north (left) bank approximately 1000 feet upstream from the dam.

Photo 4 - View of reservoir from
right (south) abutment.

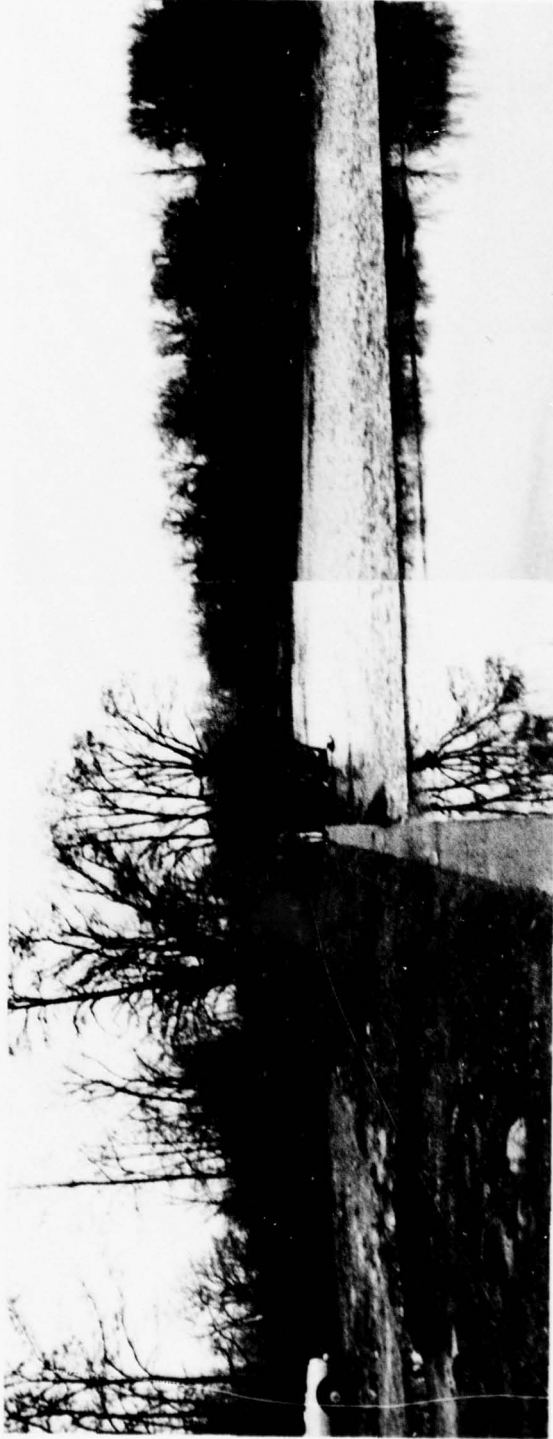
Photo 5 - View looking downstream from left (north) abutment.
